Reserve Silica Corporation Site Cleanup Status Update Winter 2019

Solid Waste Management Program
Northwest Regional Office

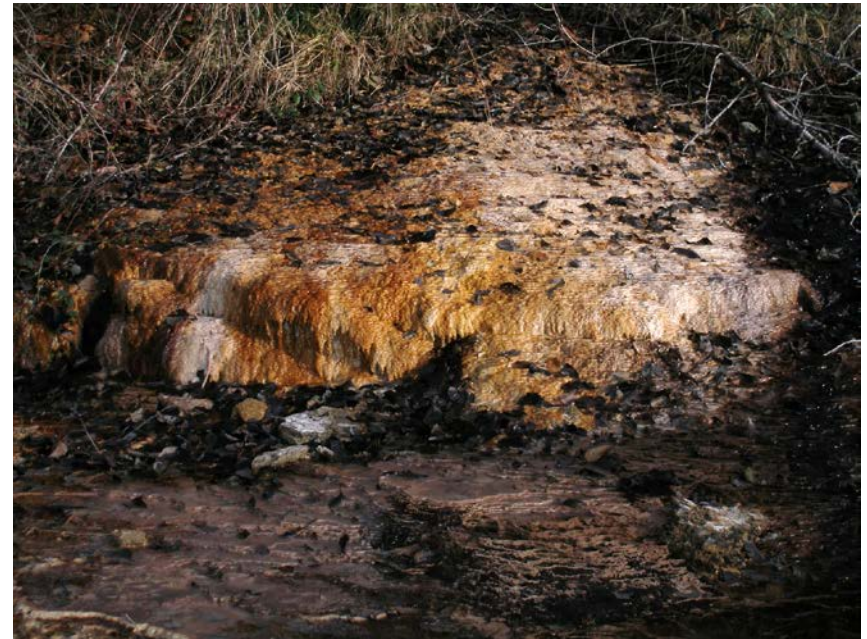
Lower Disposal Area Leachate

- Leachate seeps to surface water documented since 1986
- Elevated pH and arsenic concentrations in south pond and infiltration pond
- Interceptor trenches installed at the time

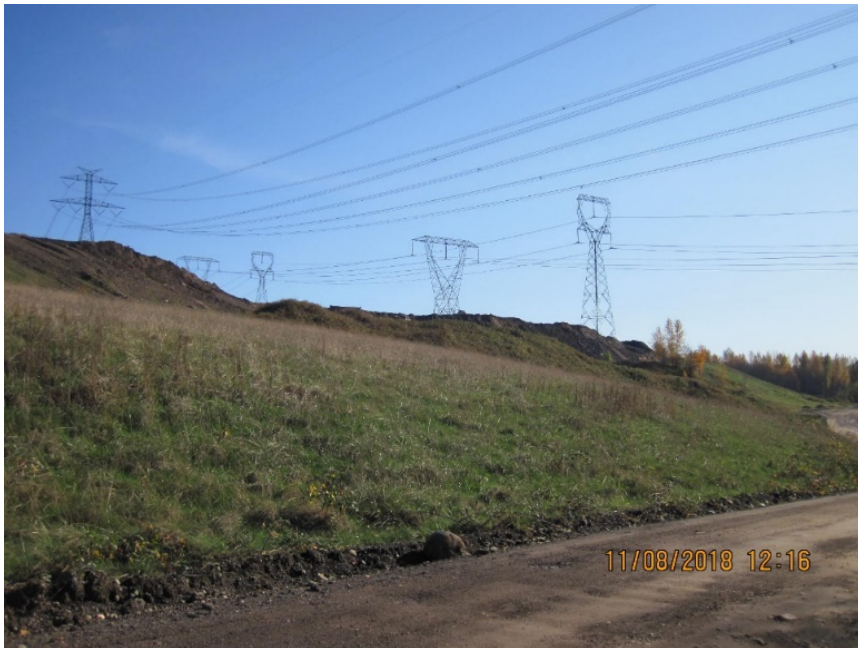
Lower Disposal Area
September to October 2007

Cover Restoration

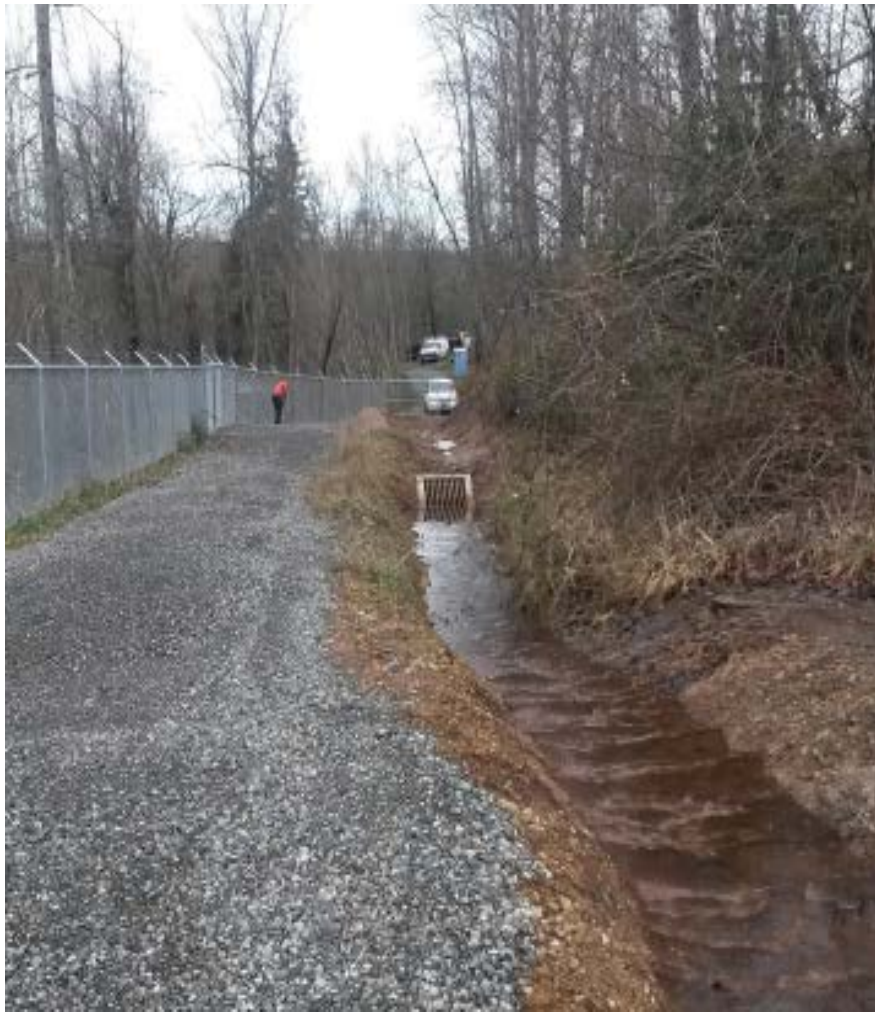
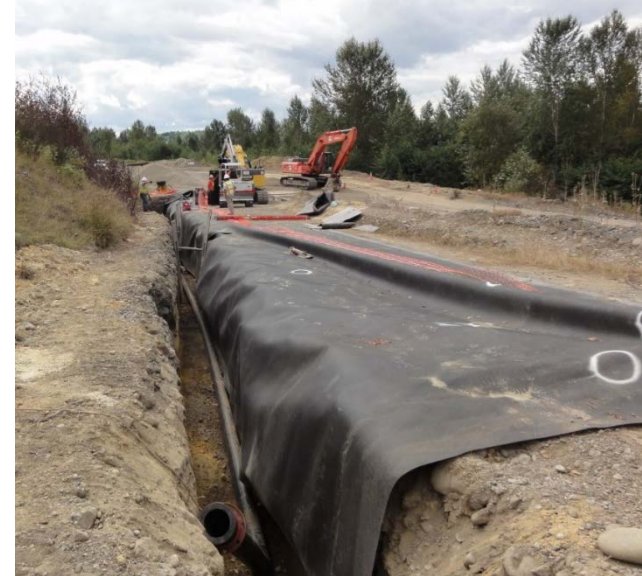
Lower Disposal Area

2008 – Test trenches

2009–2012 – Monitoring and hydrogeological studies

2013 – Seepage collection and diversion trenches

2017 – Trench extension and conveyance upgrades

2018 - Seepage treatment system

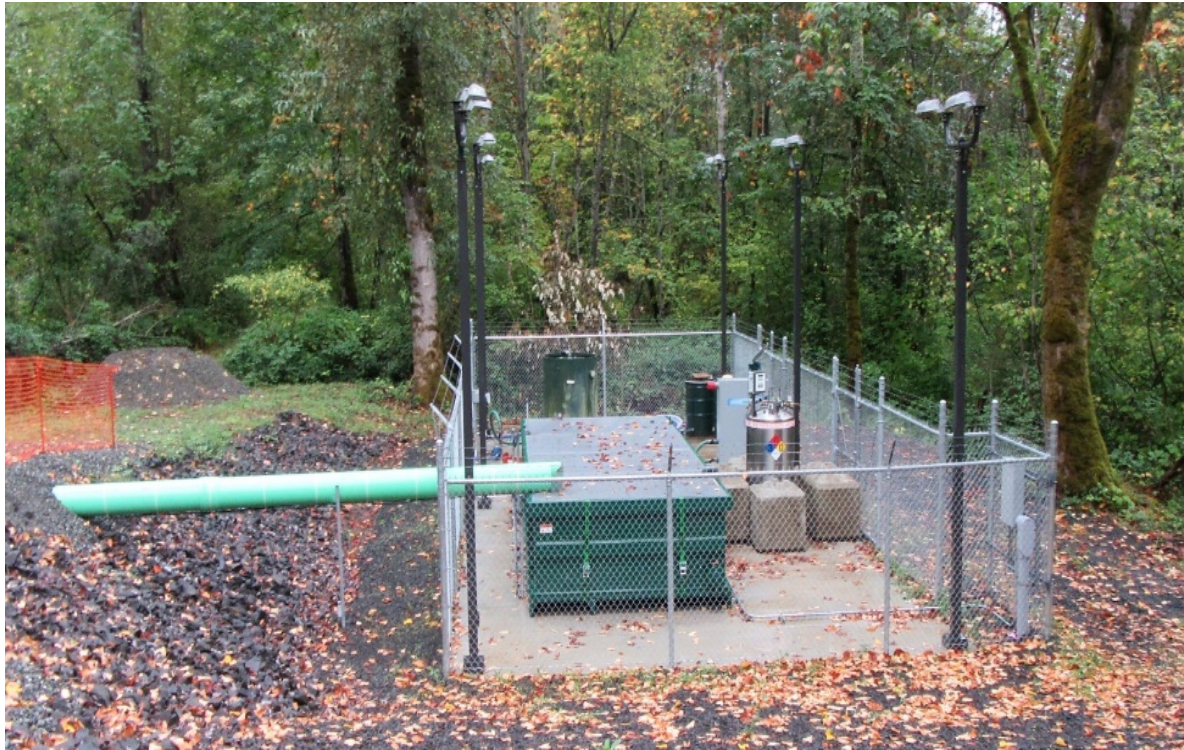
2018 Seepage Treatment System

- CO₂ Sparging System – Neutralizes pH, lowers arsenic and lead concentrations
- Iron filings – Adsorbs residual arsenic

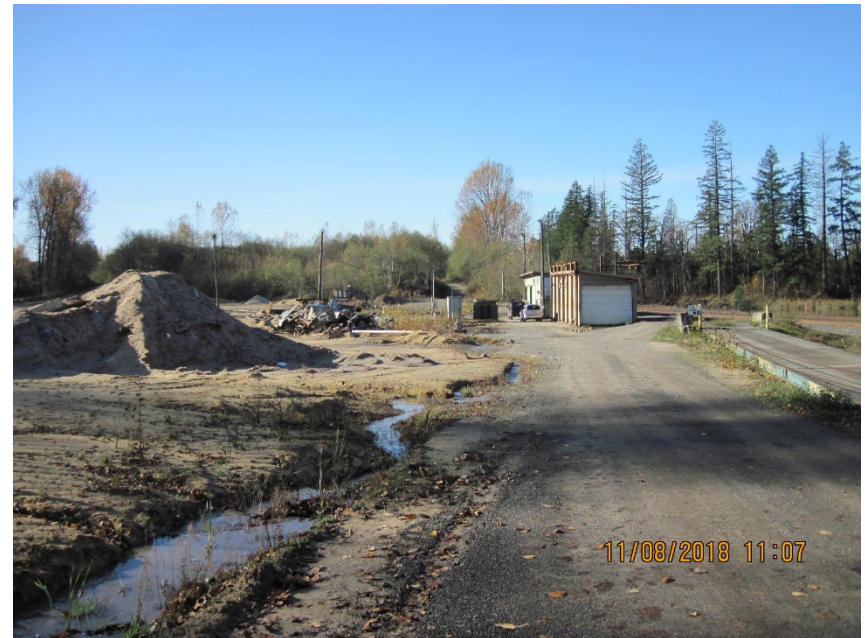
Plant Site

Historical mining activities for coal and sand

- Coal mining ended 1950
- Sand mining ended 2007

Decommissioning started 2015

Investigations of environmental conditions
