DRC REPORT TO LANDMARKS COMMISSION
January 26, 2016

**APPLICATION FOR TYPE III CERTIFICATE
OF APPROPRIATENESS (#1527):**

Pacific Coast Coal Admin Building

Project proposal: Demolish the building.

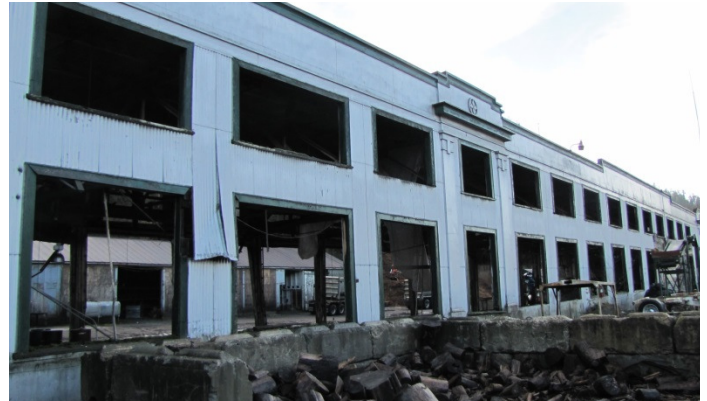
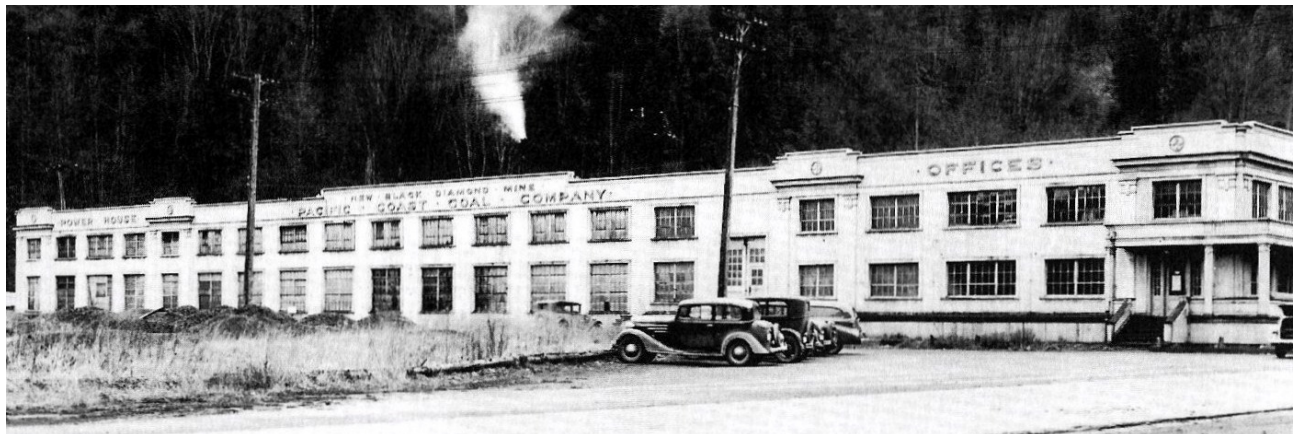
Since that time the building has been vandalized numerous times and all interior equipment has been stripped. The building is constructed of shiplap wood siding covered with corrugated metal panels. In the shop area, large steel trusses set on timber posts span the interior. Sections of the roof are gone, and portions of the exterior siding are missing. Nearly all doors and windows have been removed and there are large areas of mold in the office wing. A porch at the west end was also removed because it was about to collapse.

If it were to remain and be placed in some productive use it would have to be rebuilt. Since the owner also does demolition, they plan to take it down themselves, and recycle whatever is left. The metal panels and steel trusses can be sold for scrap, the shiplap siding will be used for fuel, and the concrete slab broken up. There are a few decorative metal pieces on the building, and the owner has promised them to the heirs to the family that started the mining operation at the site. Very little else is worth salvaging.

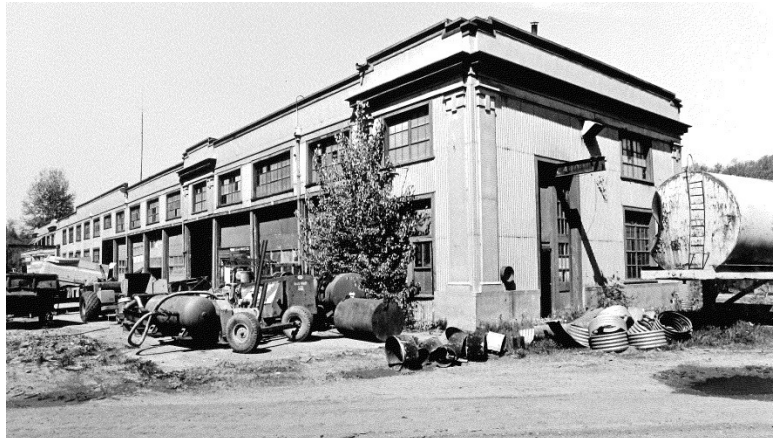
- exterior portions of the building
- interior of the shop
- railroad trestle
- concrete foundation of the washhouse
- all land area within the boundaries.

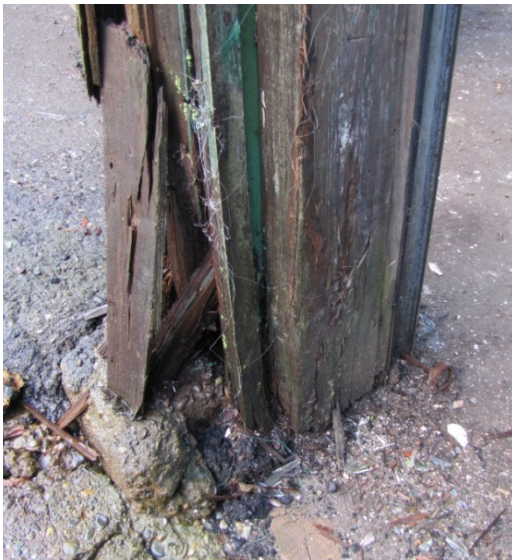
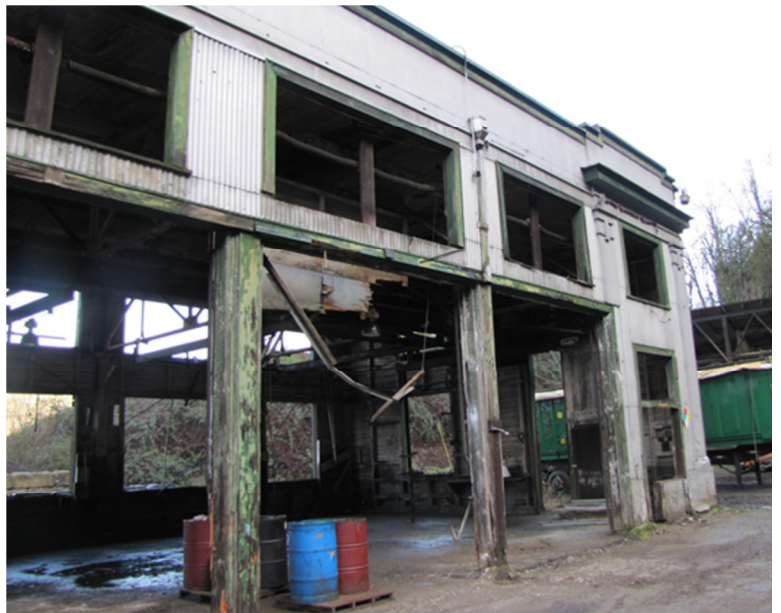
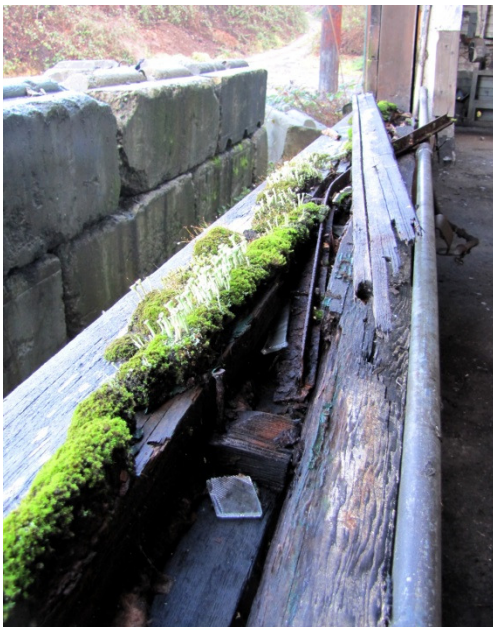
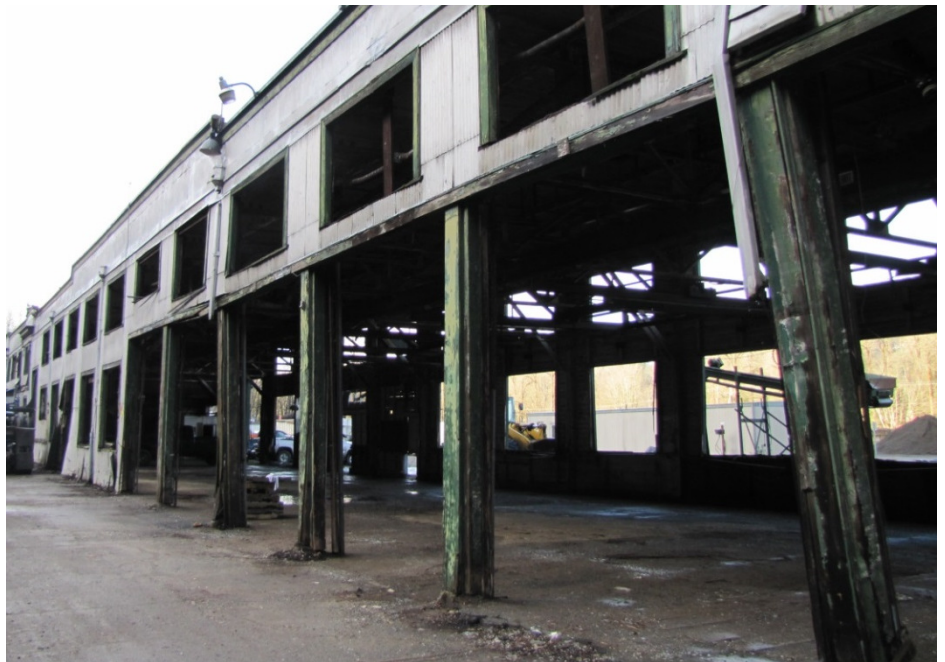
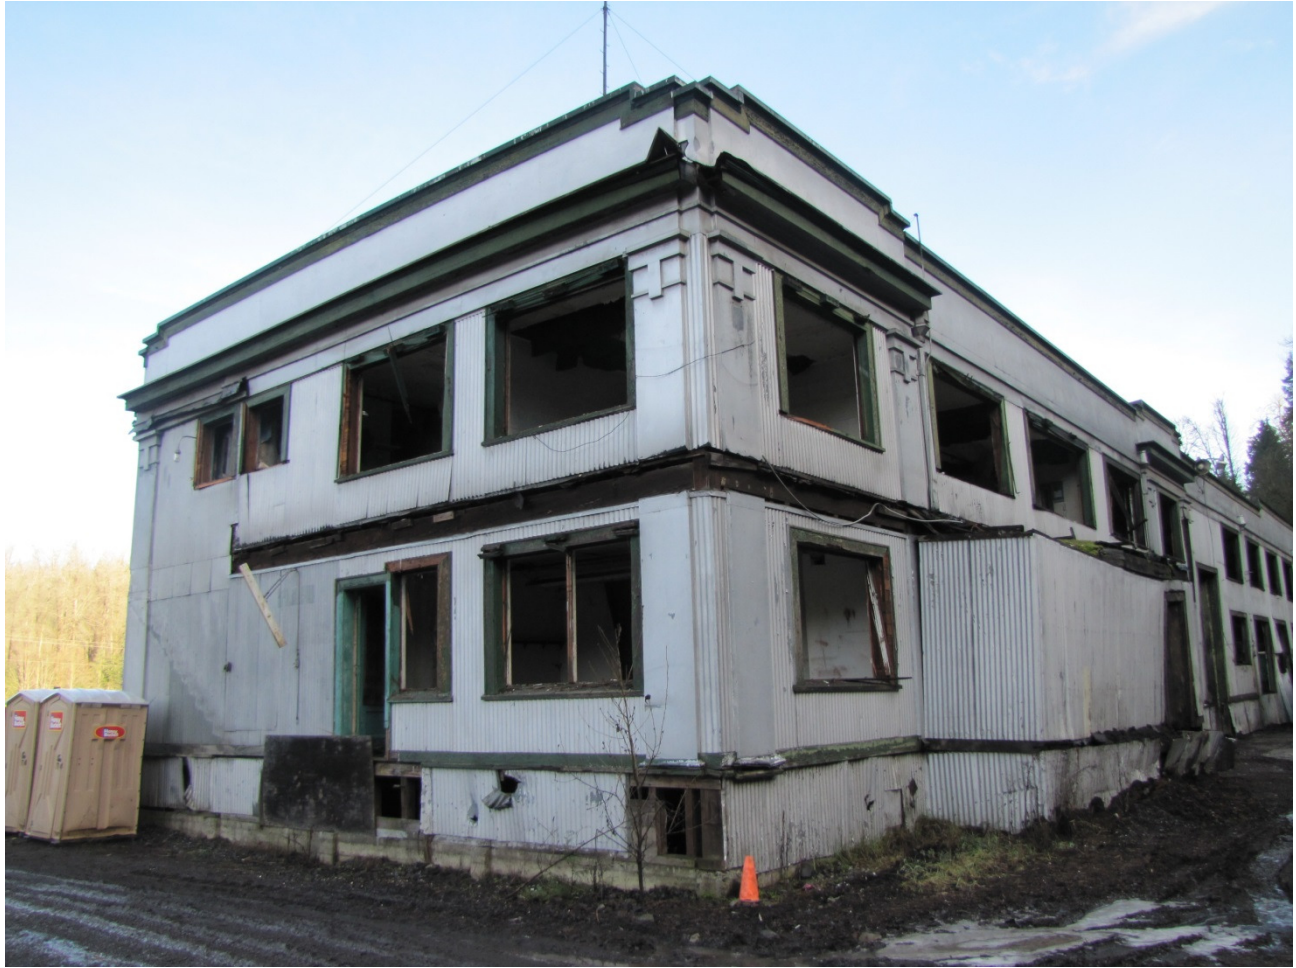
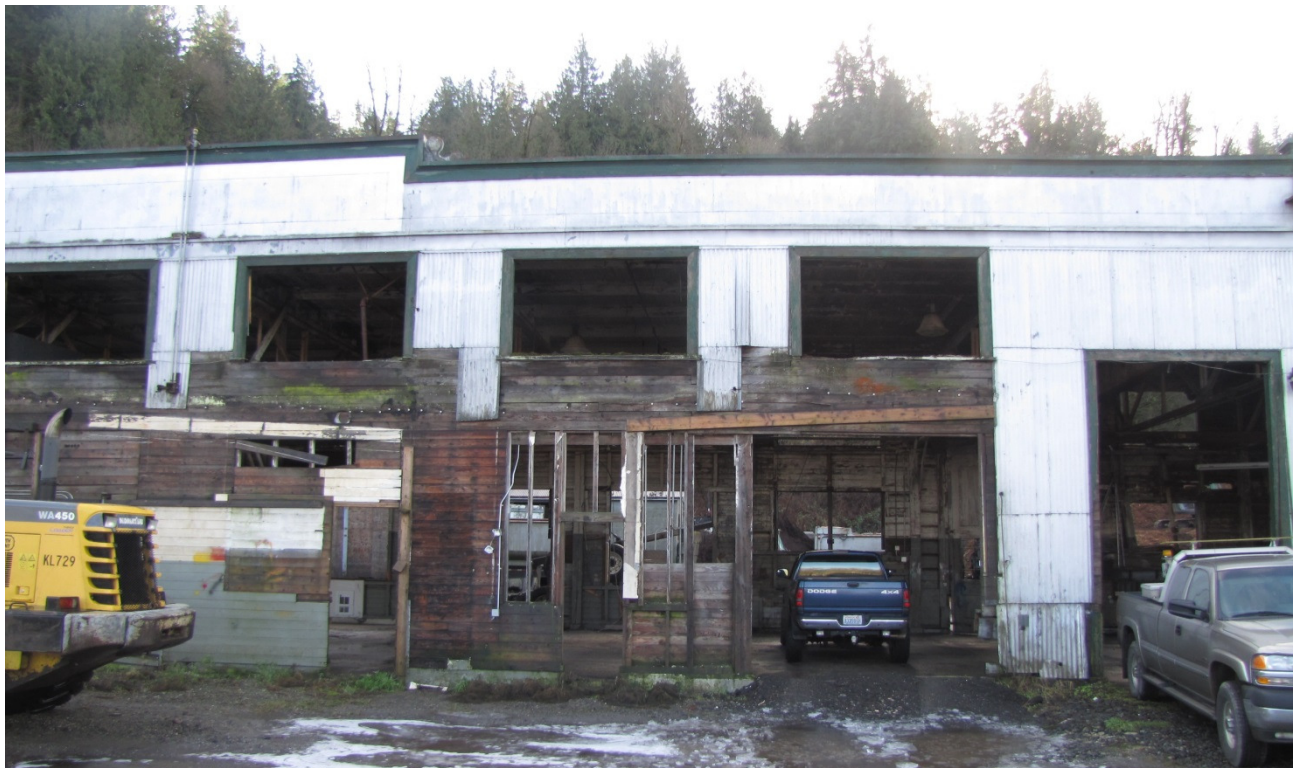
This standard is met, in balance. The owner/applicant has not yet provided an independent analysis or any other supporting information that demonstrates there is a major and imminent threat to public safety. However, the commission’s staff architect has toured the building and feels it cannot be salvaged. The flat roof has significantly deteriorated and has large holes in it; the structural supports between garage bays are rotting at the base, and several of them have failed; and both floors of the office end of the building have become saturated and are growing mold. A heavy snow or strong wind in the right location could cause parts of the building to collapse.

Available alternatives to rectify the threat include temporary securing of the building or complete reconstruction. Partial reconstruction or repair is not possible due to the deteriorated condition and loss of siding, roofing, windows, doors, and structural supports. Temporarily securing the building would require a significant investment in fencing and plywood to cover the windows. The building is so large and has so many window openings that it would be easy to spend several thousand dollars just for the materials to secure it. In many locations it would be difficult to attach plywood to the window frames because those frames have rotted away. The location of the building, in a remote location with no neighbors has invited vandals over the years, and any fencing or boarded windows would likely encourage more; the fencing and boarded windows could easily be breached during nighttime hours.

The DRC recommends **approval** of the request with the conditions that the applicant photograph the building prior to demolition, and provide staff with adequate documentation of condition and insurance cancellation.
